**Title:** Summary of Activities for Nondestructive Evaluation of Insulation in Cryogenic Tanks

**Center POC:** Ellen Arens

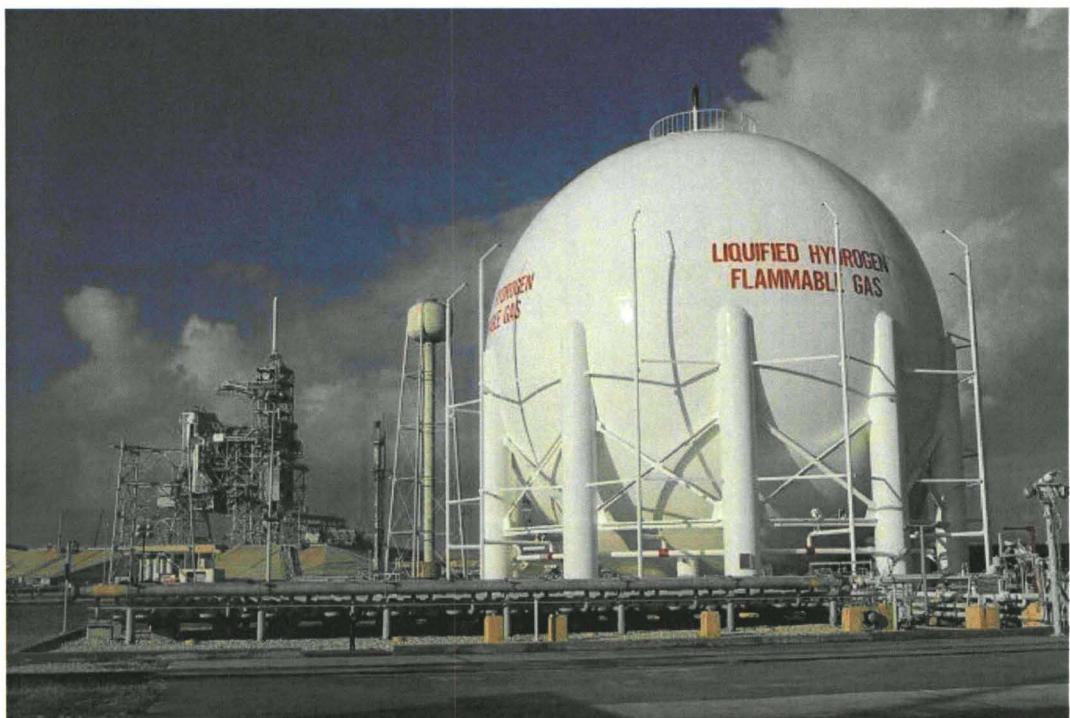
In the first two years of the project thermal imaging, using the sun as the thermal heat source with and without cryogenic fluid in the tank, was demonstrated as a useful tool for determining the underlying mechanical structure of the tank and for identifying locations of large insulation voids. It was shown that large insulation voids were detectable even in a tank with no cryogenic fluid in it due to the slight temperature differences cause by day to night cycling.
